# **Assessing the Health and Resilience of Dune Systems as a Coastal Defence**

**KPAL Report No. 200325**

## **KPAL External Investigation Report No EX200325**

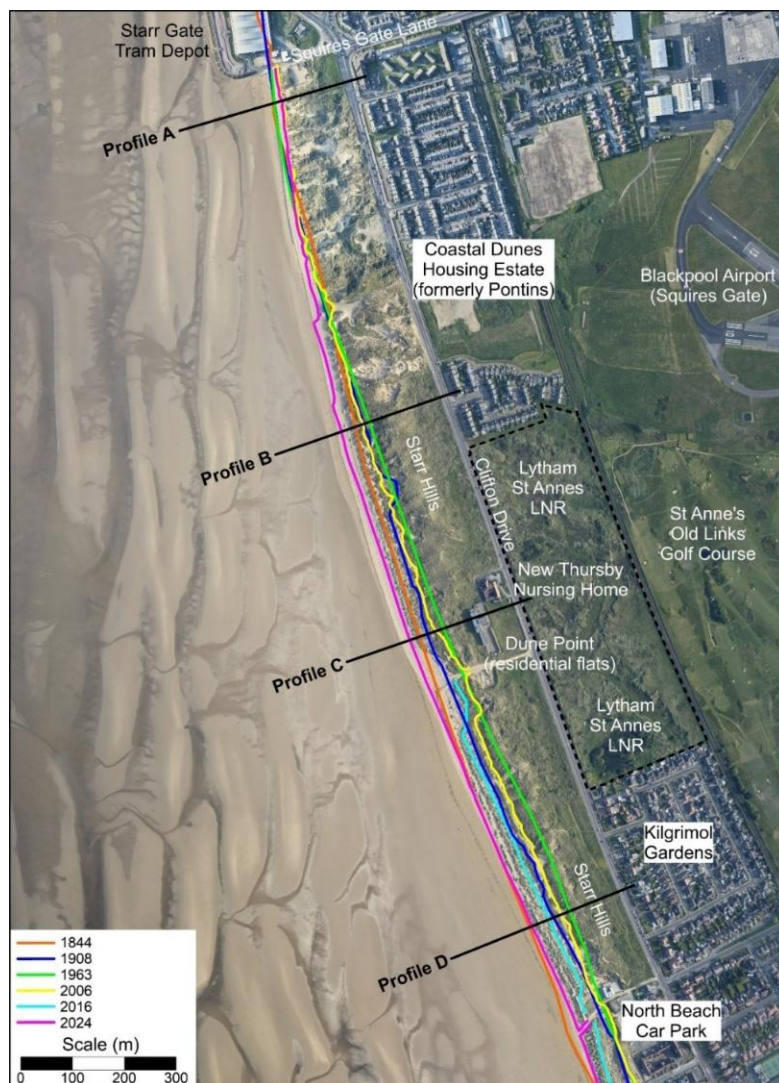
**Figure 22.** Aerial photography of the Starr Hills dunes between Blackpool and Lytham flown 11/05/2024, overlain with historical positions of the dune toe from OS maps (surveyed 1844, 1908 and 1963), aerial photography (2006, 2016 and 2024) and RTK-GNSS survey (07/03/2016 and 08/10/2024). Source: Channel Coastal Observatory

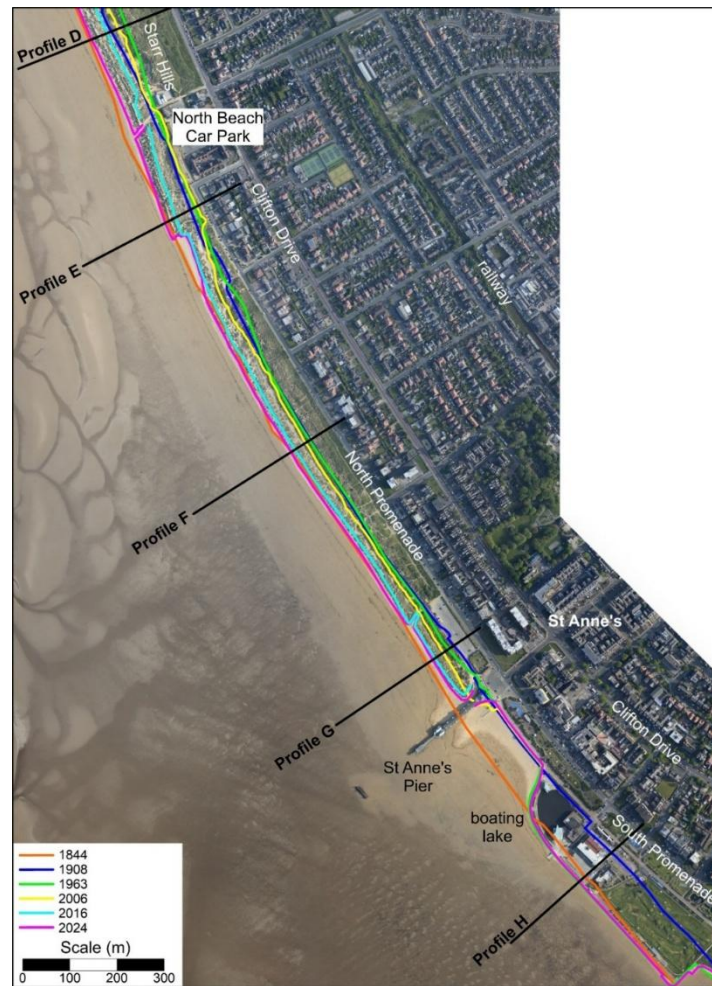
**Figure 23.** Aerial photography of the Lytham St Anne's area flown 11/05/2024, overlain with historical positions of the dune toe from OS maps (surveyed 1844, 1908 and 1963), aerial photography (2006, 2016 and 2024) and RTK-GNSS survey (07/03/2016 and 08/10/2024). Source: Channel Coastal Observatory

A number of convalescent homes were developed on the seaward side of Clifton Drive in the second half of the 19<sup>th</sup> century. These sites still exist although they have been substantially modified and partly turned into apartments. The Starr Hills dunes were subject to heavy visitor pressure between the later 1920s and the closure of Pontins in 2009. There was a high percentage of bare sand and active parabolic dunes, particularly in the area to the north of the New Thursby Nursing Home (Figure 22). Many of the dune crests in the north reach 18 m ODN while those in the southern part of Starr Hills do not exceed 16 m ODN. The more recent dunes which have been formed to the south of North Beach car park through man-made intervention are significantly lower (10 - 14 m; Figure 23).

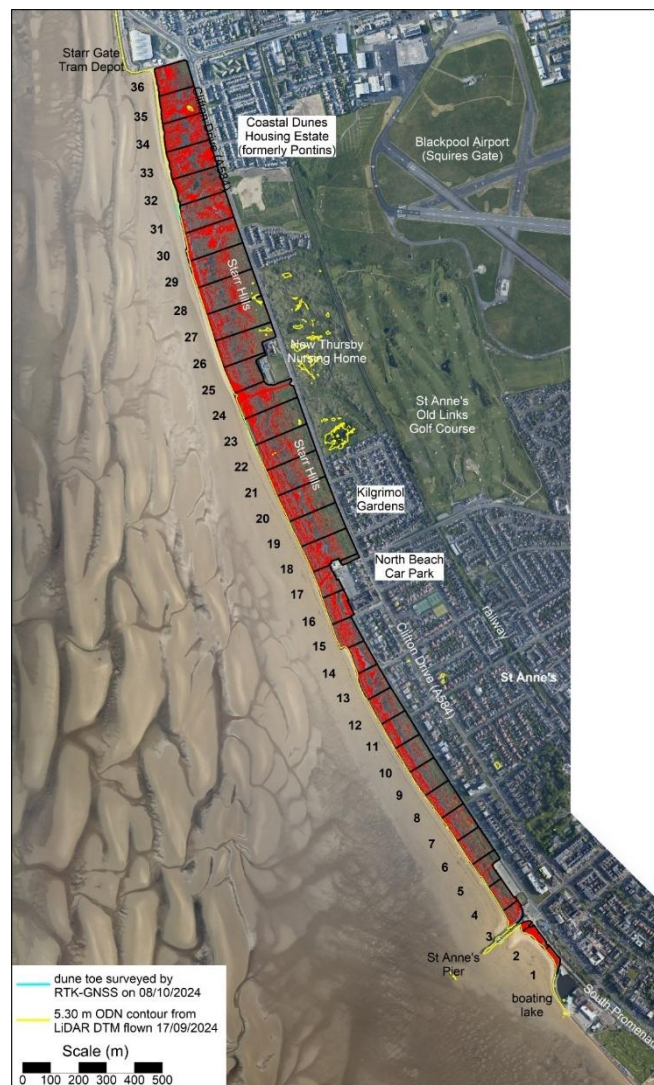
**Figure 30.** Extent of bare sand (red) in the dunes at St Anne's North Beach superimposed on aerial photography flown 11/05/2024. The positions of 36 defined dune cells (100 wide) are also shown. Photography source: Channel Coastal Observatory

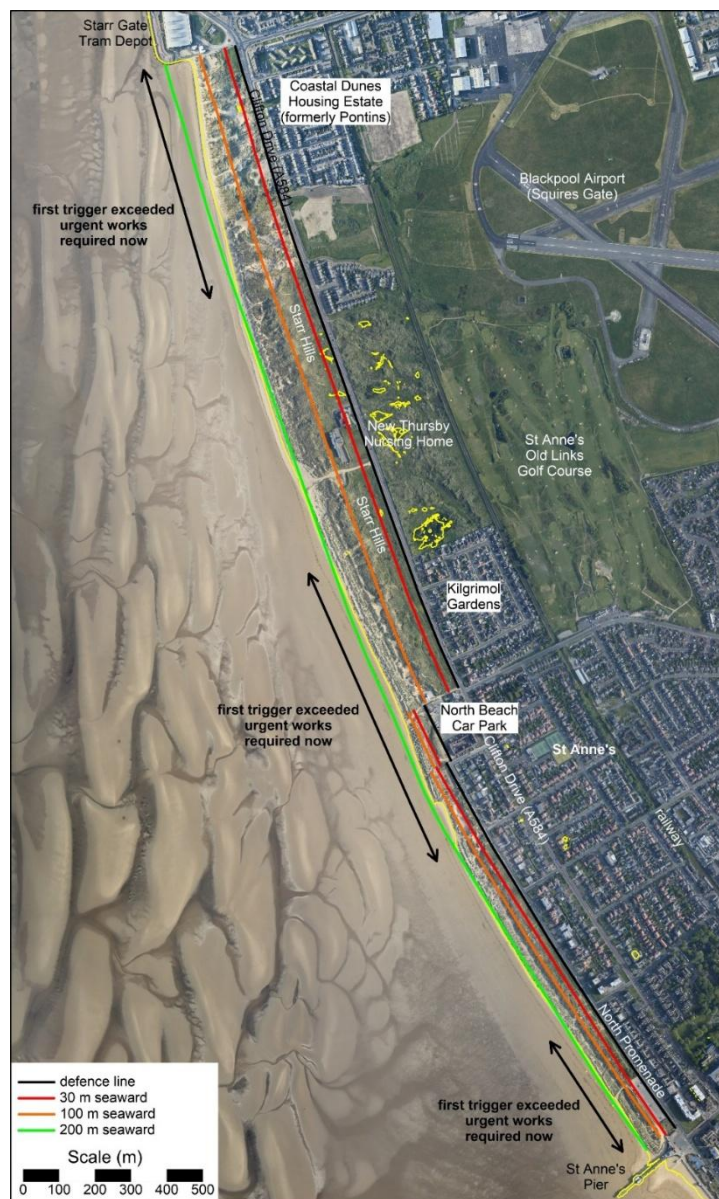
**Figure 31.** Suggested buffer zones and action trigger lines for St Annes North, with the current main defence line shown in black, coinciding with the North Promenade at St Annes, the North Beach Car Park wall, and Clifton Drive. Also, trigger lines 30, 100 and 200 m to seaward of a probable future asset defence line.

It is suggested that present dune management should aim to achieve and maintain a belt of dunes which has a width of at least 200 m along the Starr Hills frontage (north of North Beach car park), and at least 100 m along the North Promenade and South Promenade frontages. Intervention works should continue to be undertaken to achieve these targets where they are not currently met, although this is likely to be difficult at the eroding northern end of the system without importing shingle and sand. Under present conditions it is likely to be possible along the dune frontage north of North Beach car park if more effective measures are taken to keep pedestrians off the newly accreting embryo dunes / incipient foredunes. Further dune progradation could probably also be successful along the frontage between North Beach car park and St Annes pier since the backshore has shown a consistent widening trend in this area since 2006 (see next section).

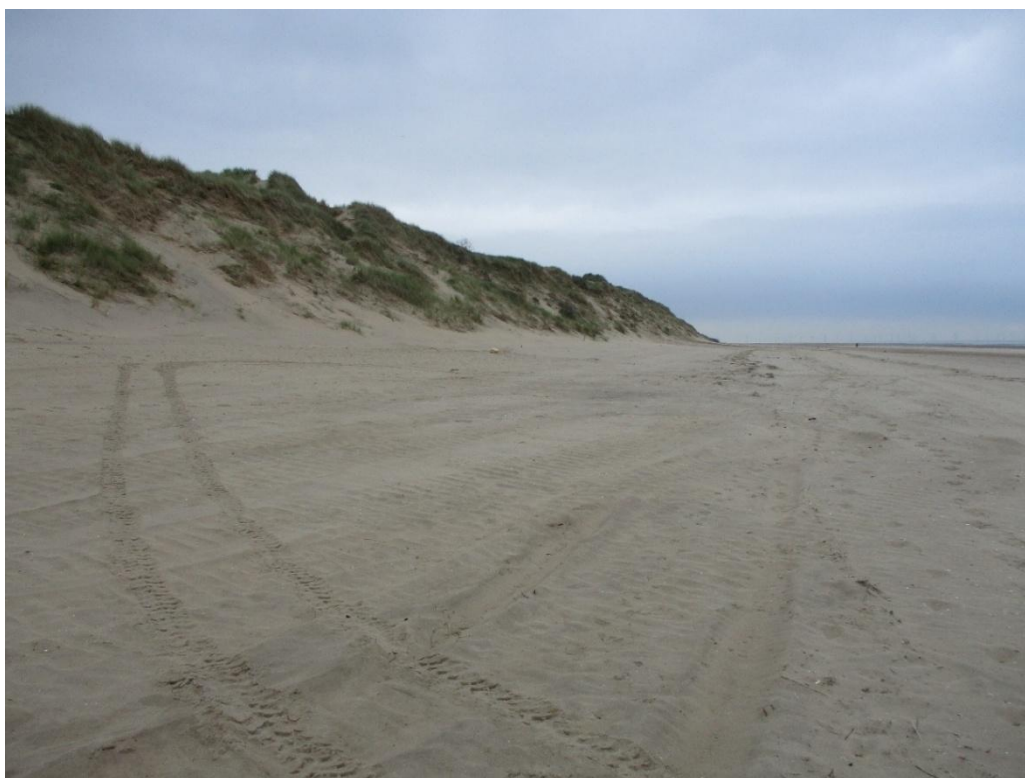
**Photograph A3.1** Steeply ramped dunes at Ainsdale North

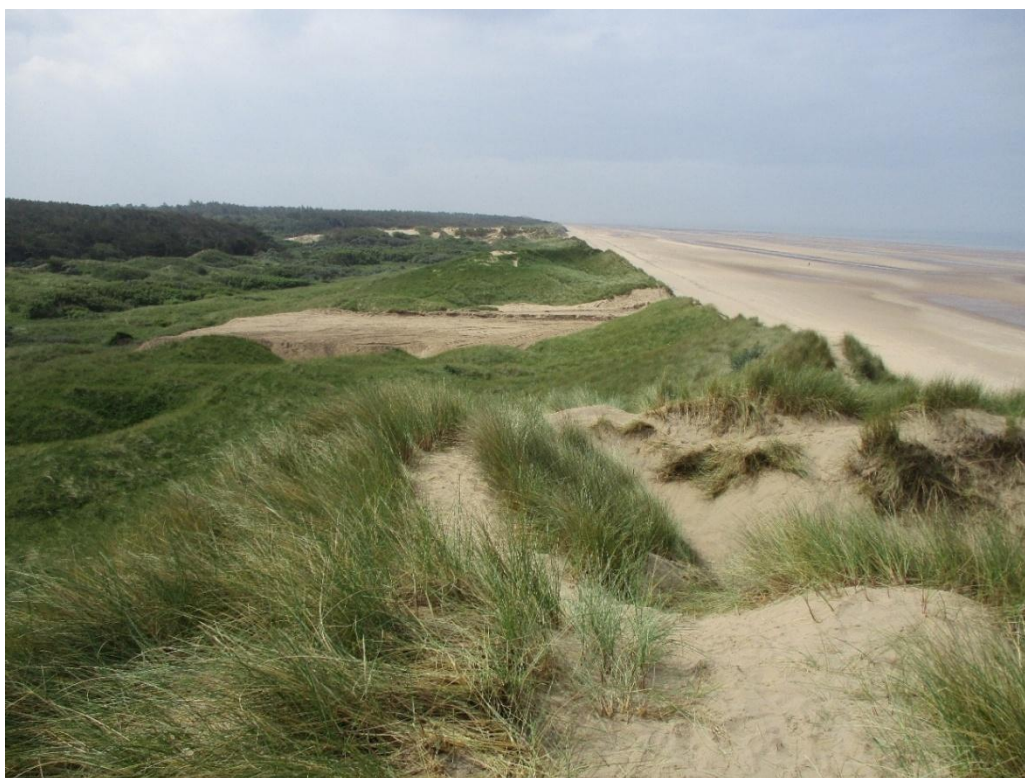
**Photograph A3.3** View south along the frontal dunes at Ainsdale North, showing notches

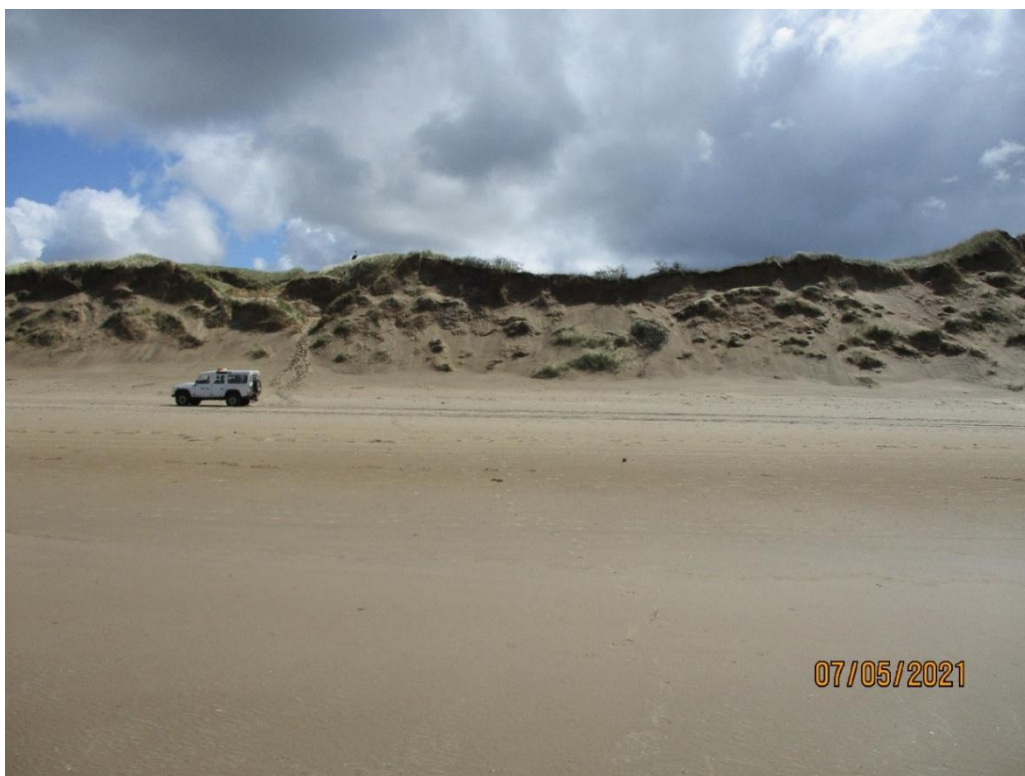
**Photograph A3.4** Eroded dune frontage north of Fisherman's Path at Ainsdale

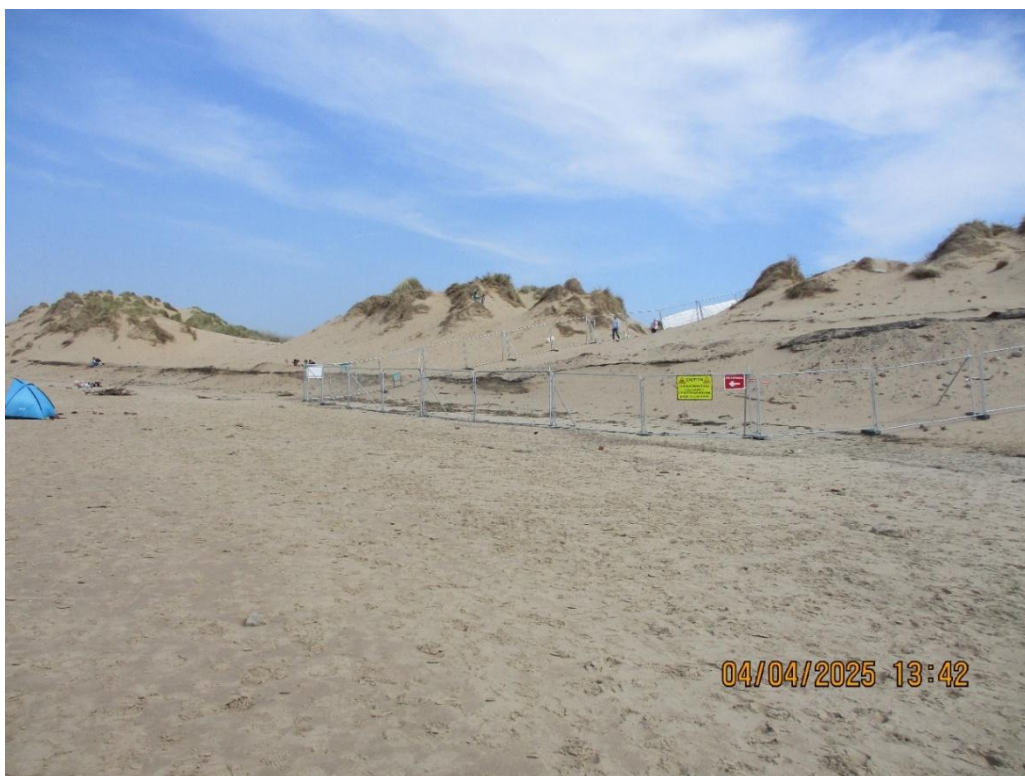
**Photograph A3.5** Degraded dunes north of Victoria Road, Freshfield

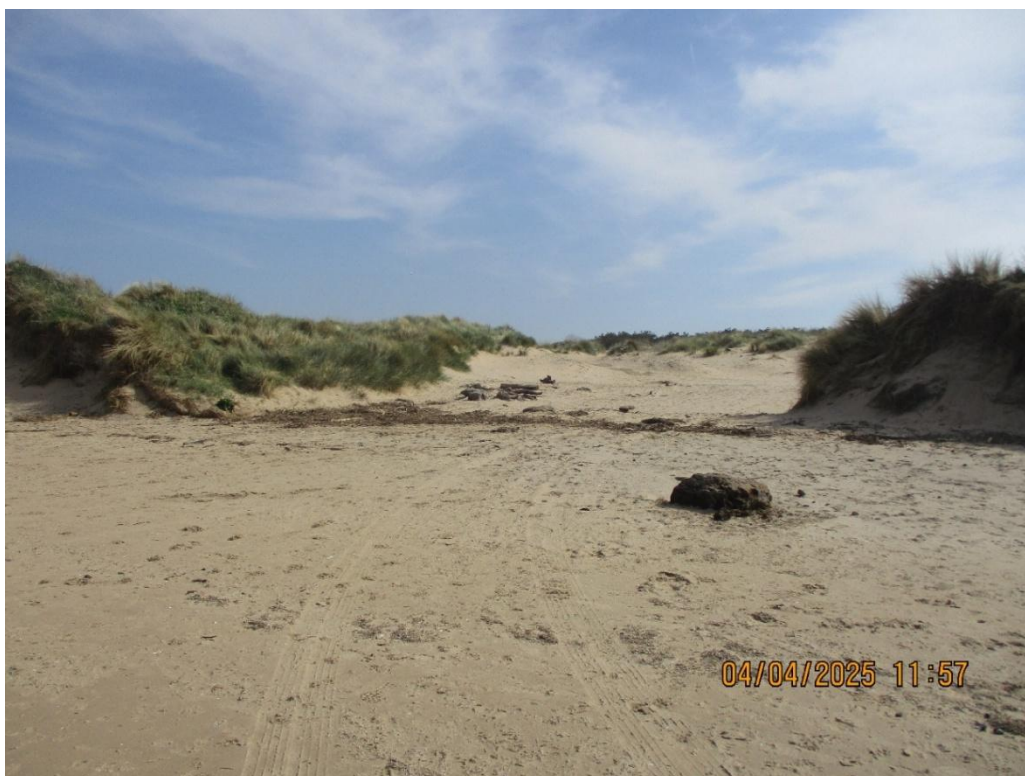
**Photograph A3.6** Blowout reaching beach level near Blundell Avenue

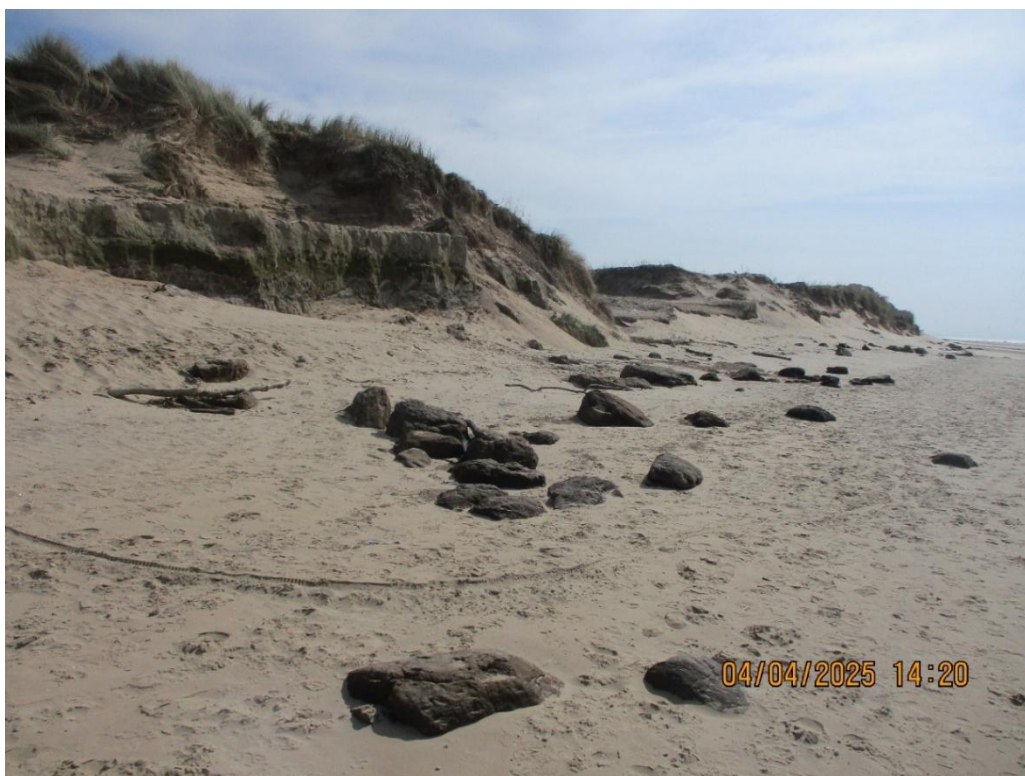
**Photograph A3.7** Eroding tobacco waste cliffs near Wick's Lane

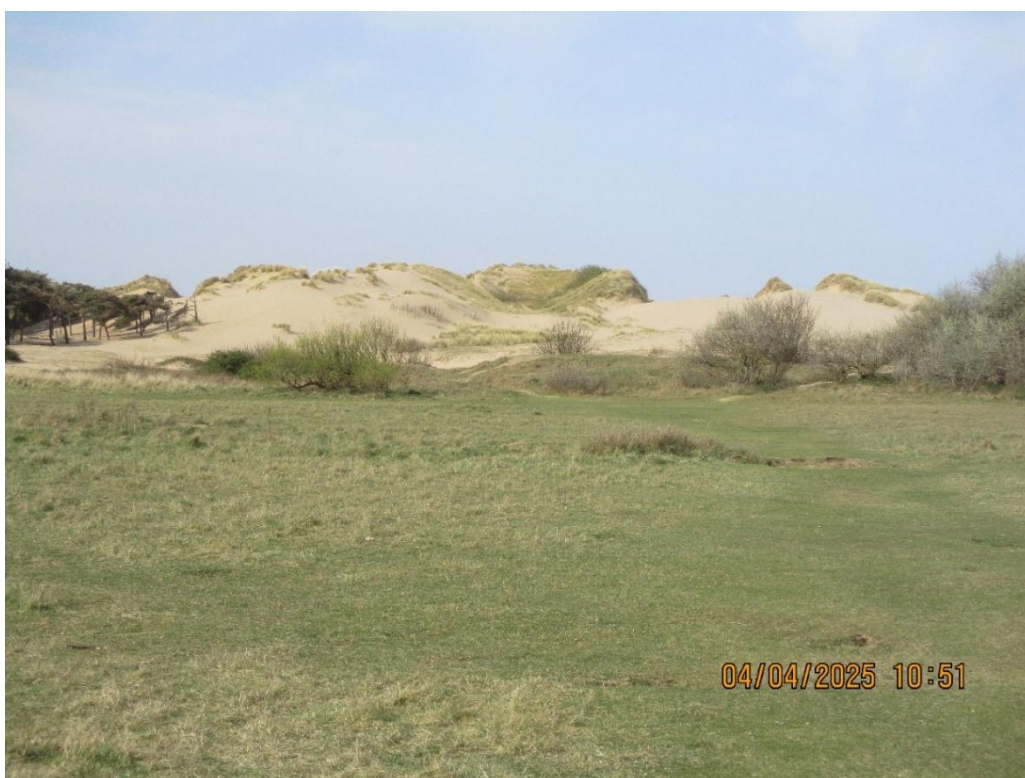
**Photograph A3.8** Advancing parabolic dunes near Blundell Avenue, view seaward

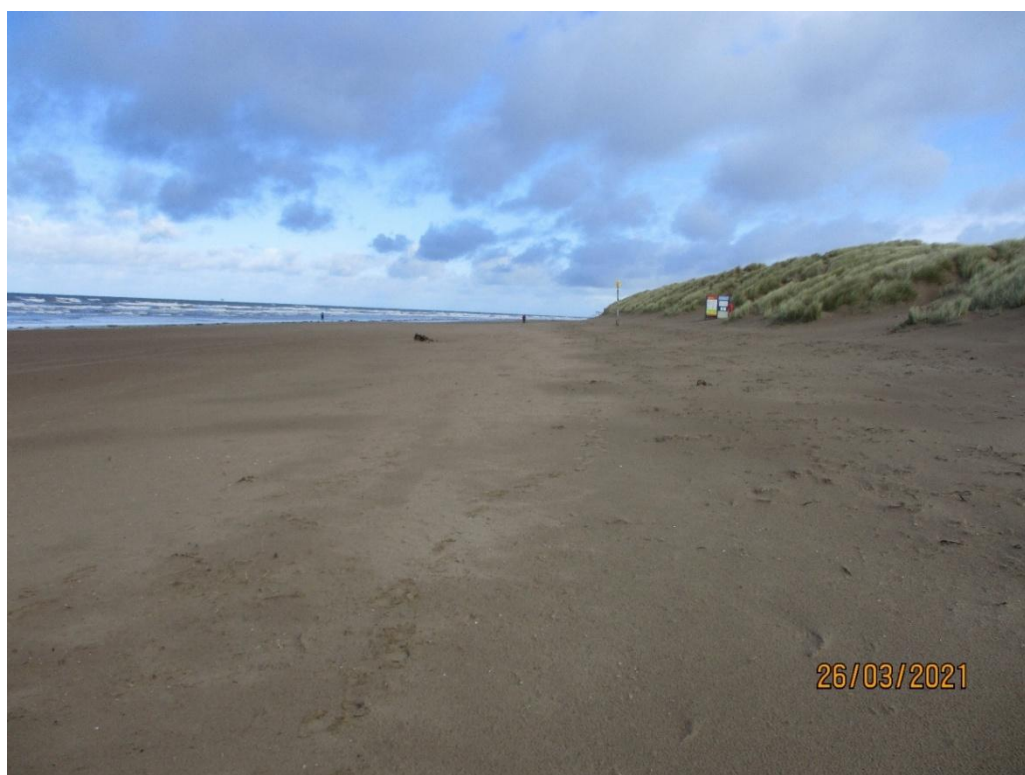
**Photograph A3.10** Accretionary frontal dune slopes south of Lifeboat Road

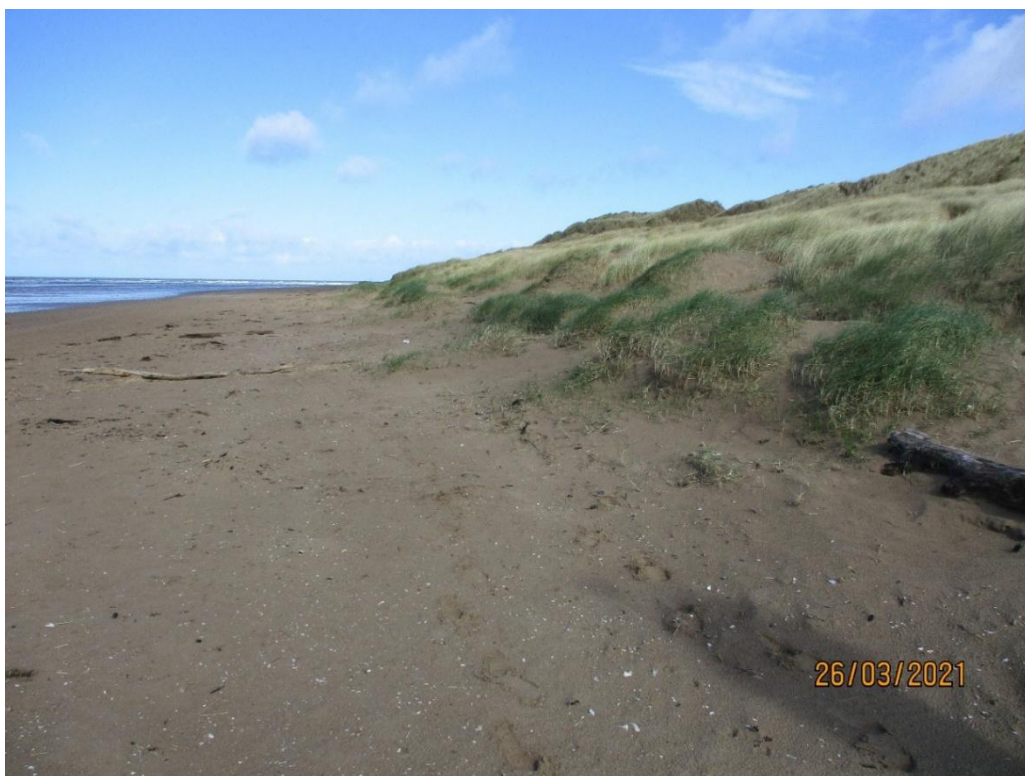
**Photograph A3.11** Accretionary dune frontage near Albert Road

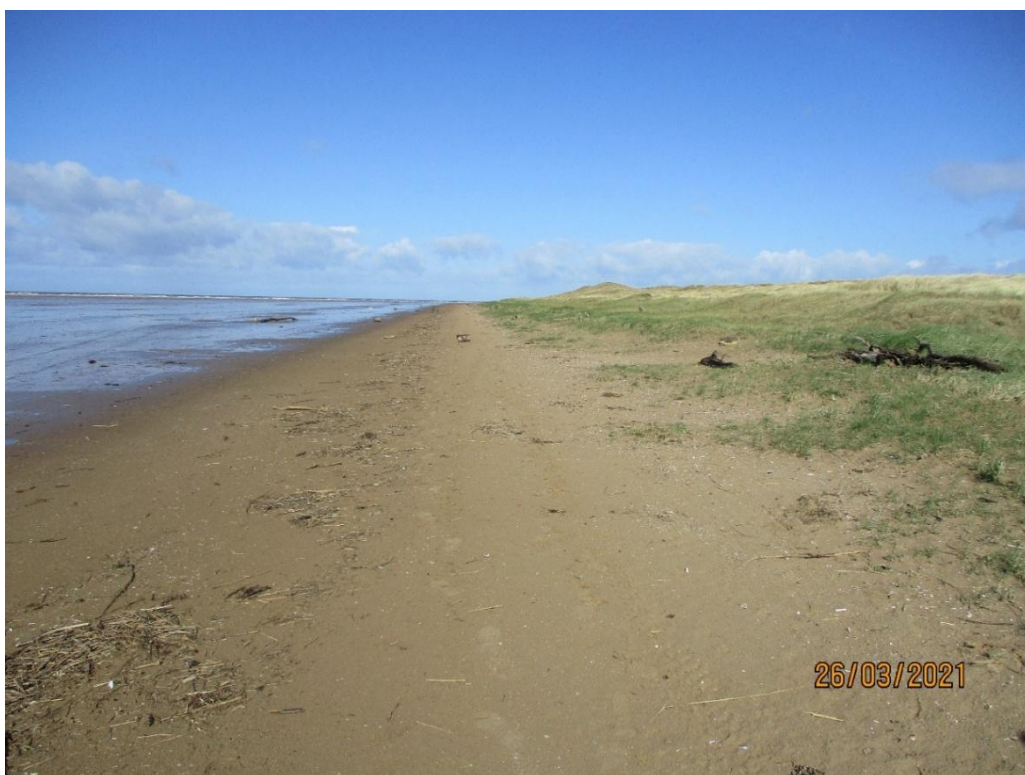
**Photograph A3.12** Accreting embryo dunes and incipient foredunes near Range Lane

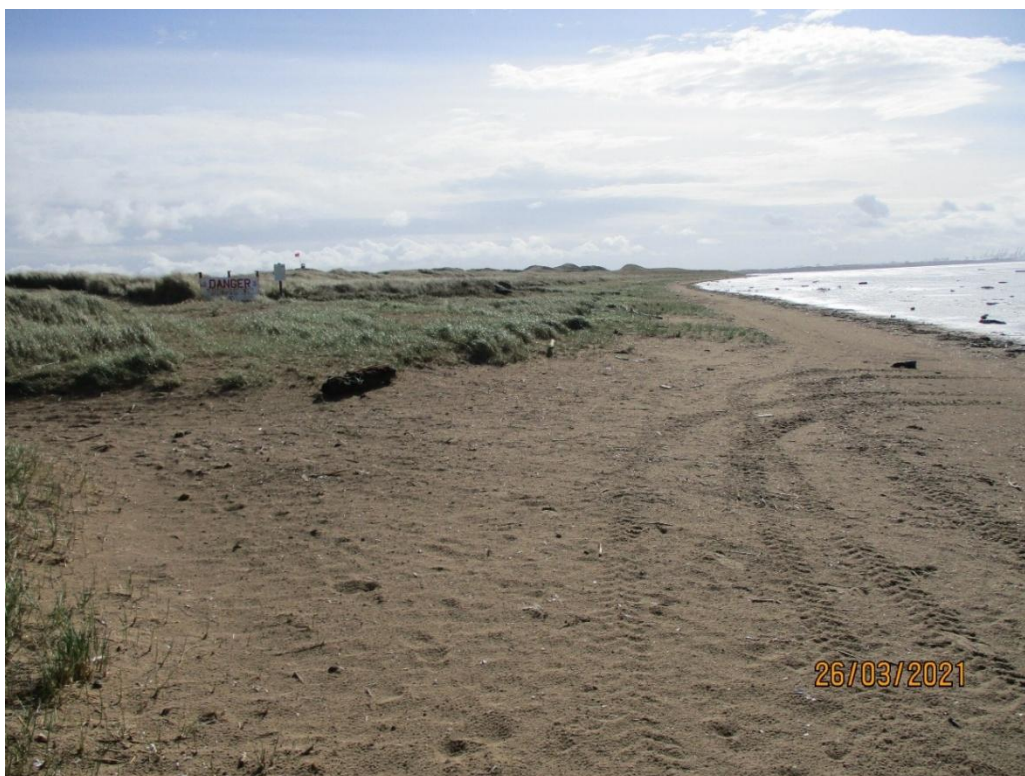
**Photograph A3.13** View south along slowly accreting dune frontage north of Altcar Rifle range

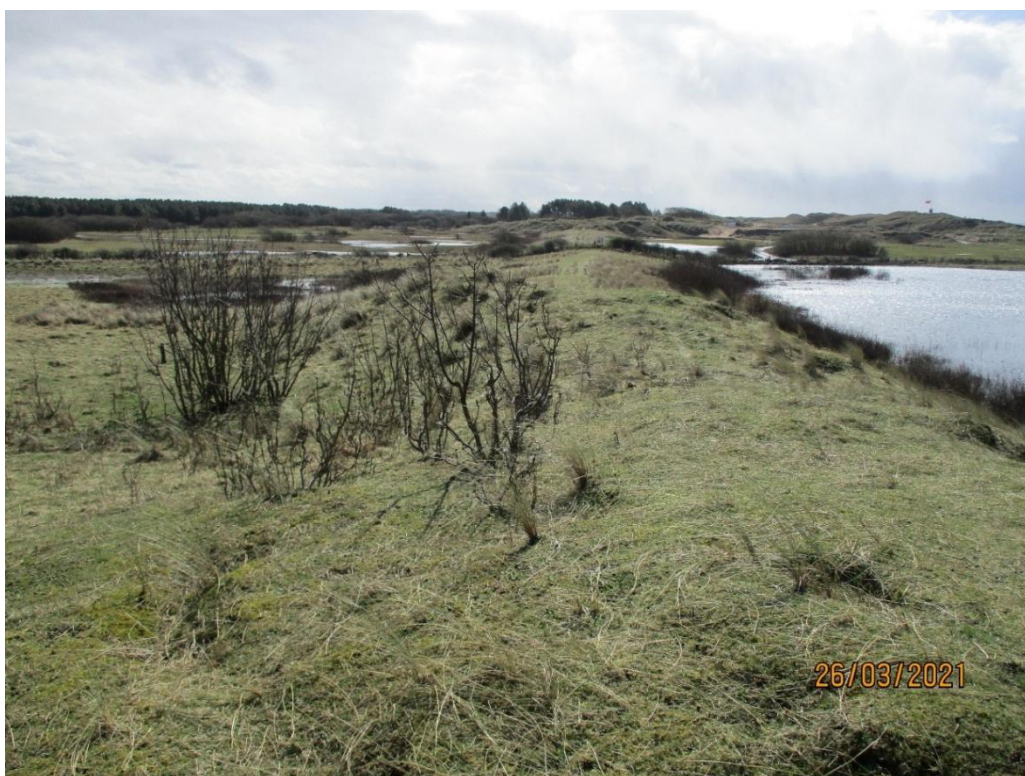
**Photograph A3.14** Artificial flood bank at Cabin Hill built in the mid 1970s

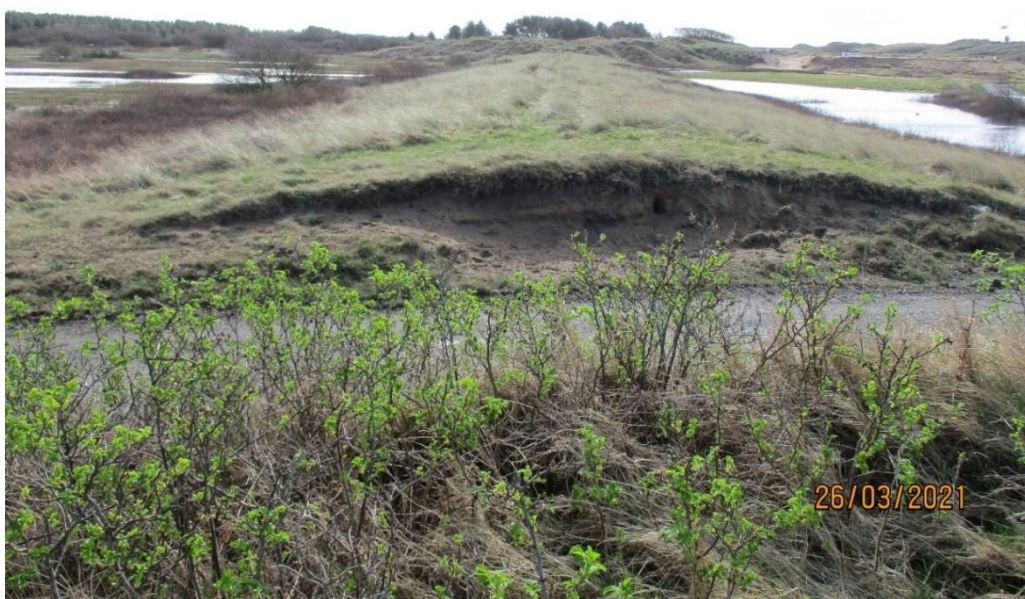
**Photograph A3.15** Gap in the bank at cabin Hill

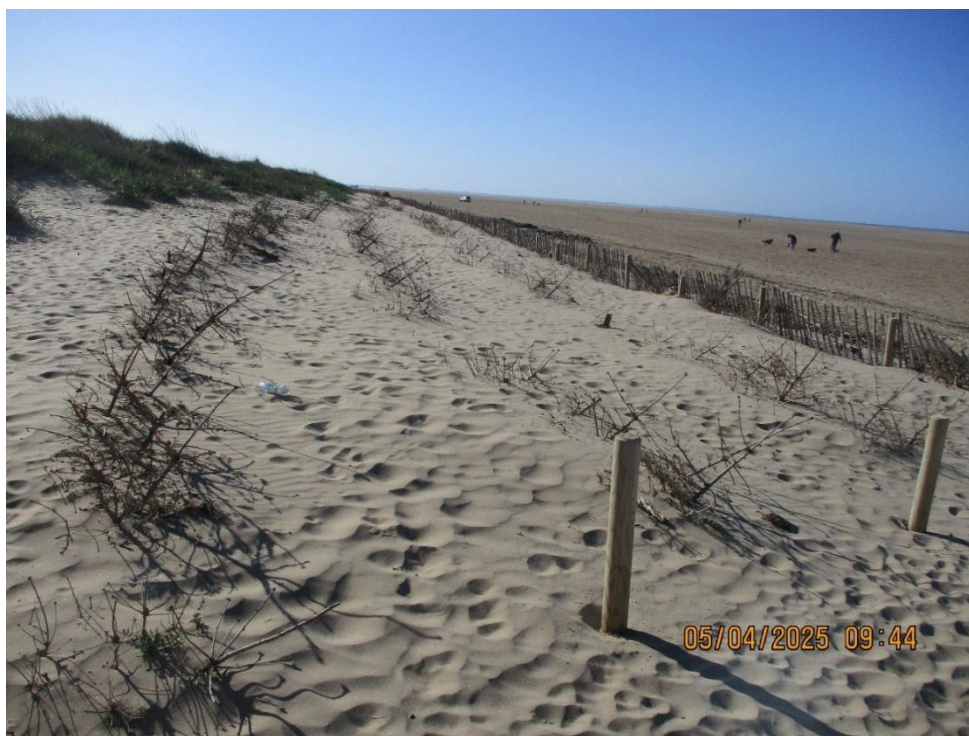
**Photograph A4.1** View south along dune edge south of North Beach car park; note chestnut paling fencing and rows of placed Christmas trees

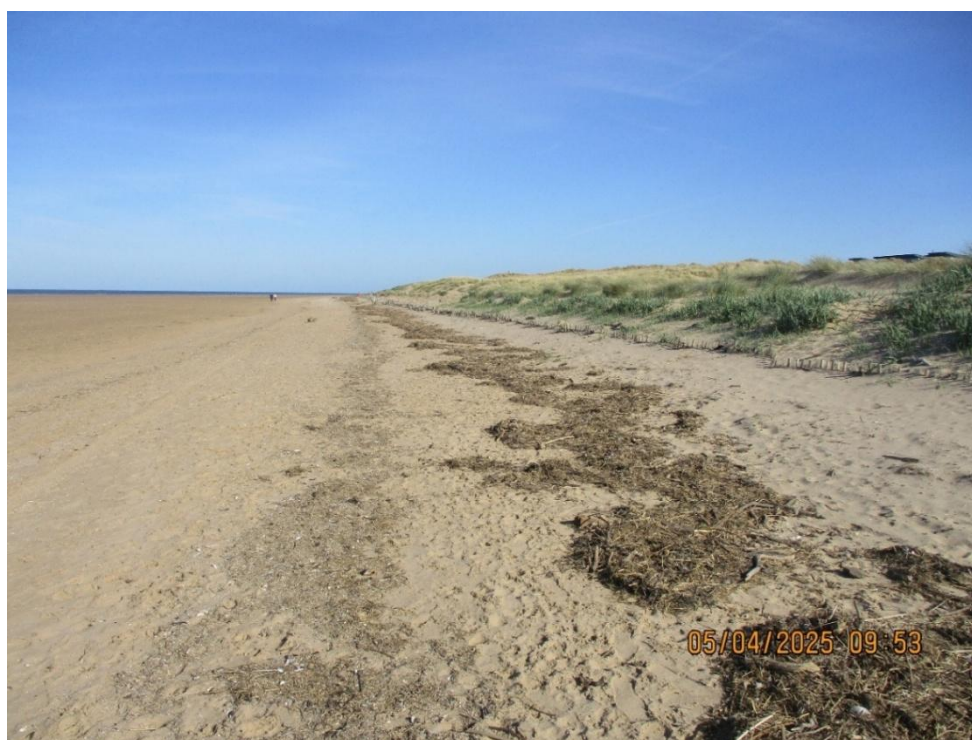
**Photograph A4.2** View north along dune edge north of North Beach car park; note buried chestnut paling fencing and old Christmas trees

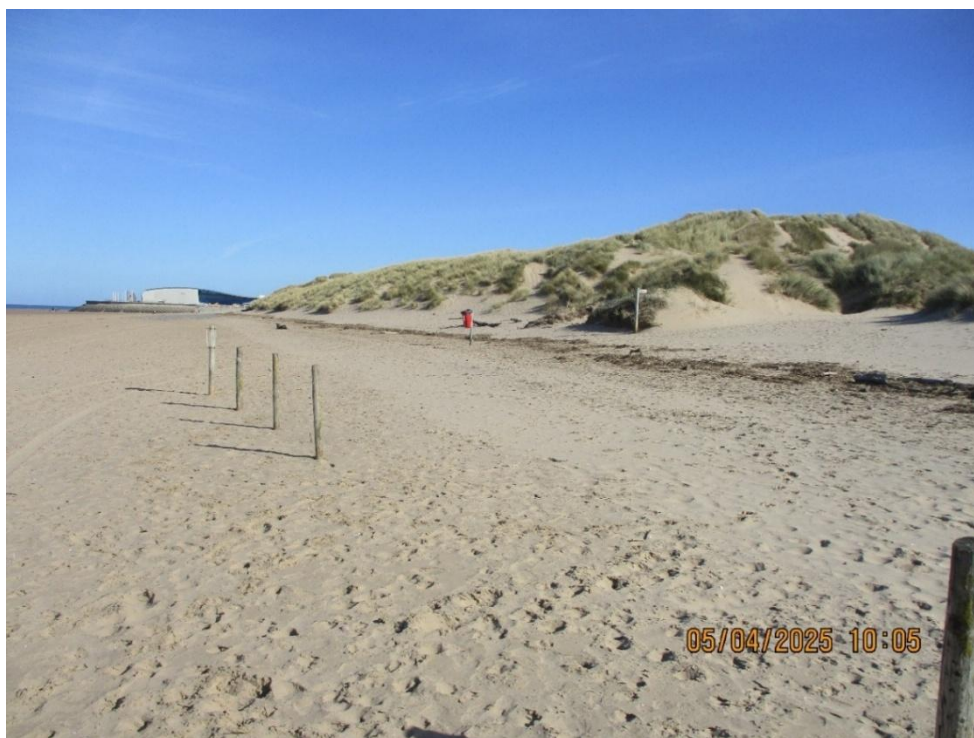
**Photograph A4.3** The northern limit of dune progradation works at Starr Hills

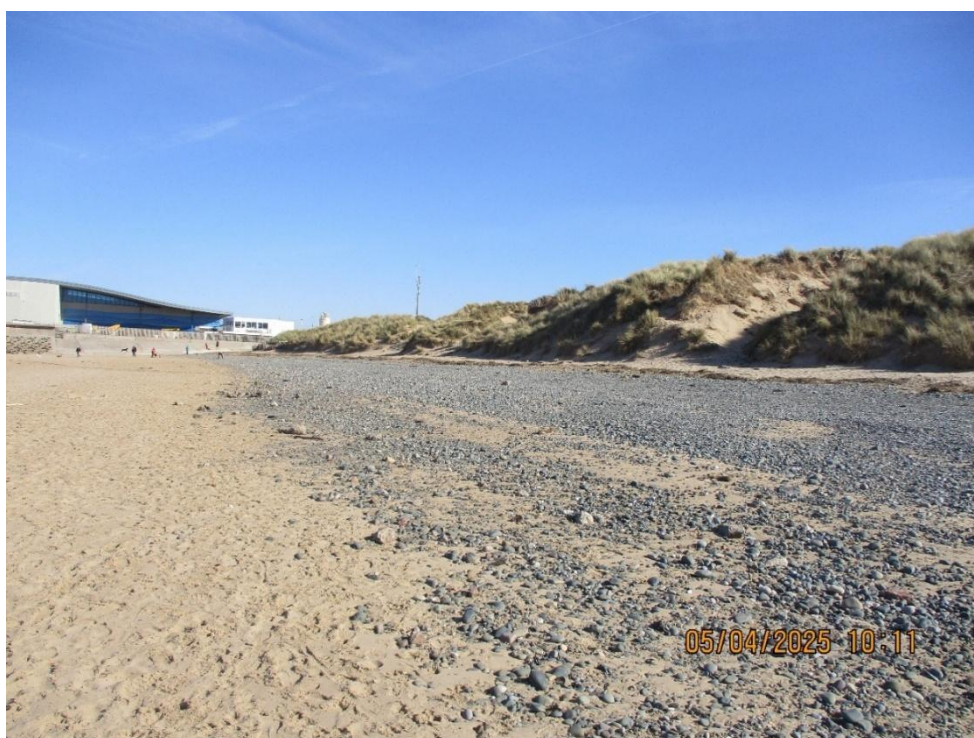
**Photograph A4.4** The section of slowly eroding dune frontage at the northern end of Starr Hills; note low shingle berm on upper beach and semi-vegetated blowouts in the frontal dunes

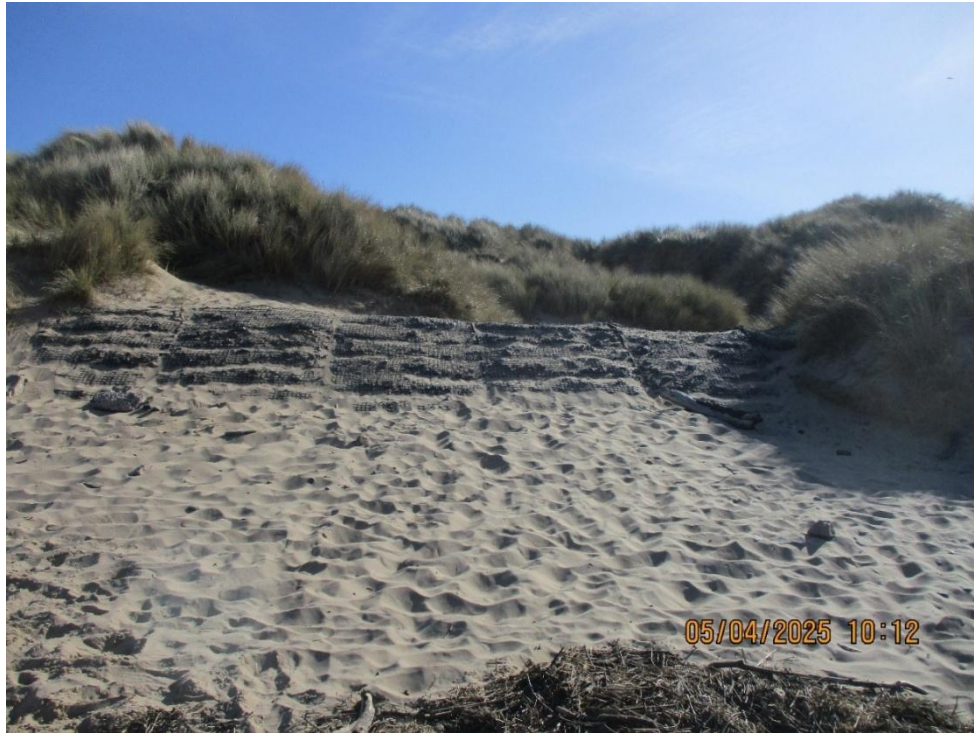
**Photograph A4.5** Sloping gabion wall at the northern end of Starr Hills

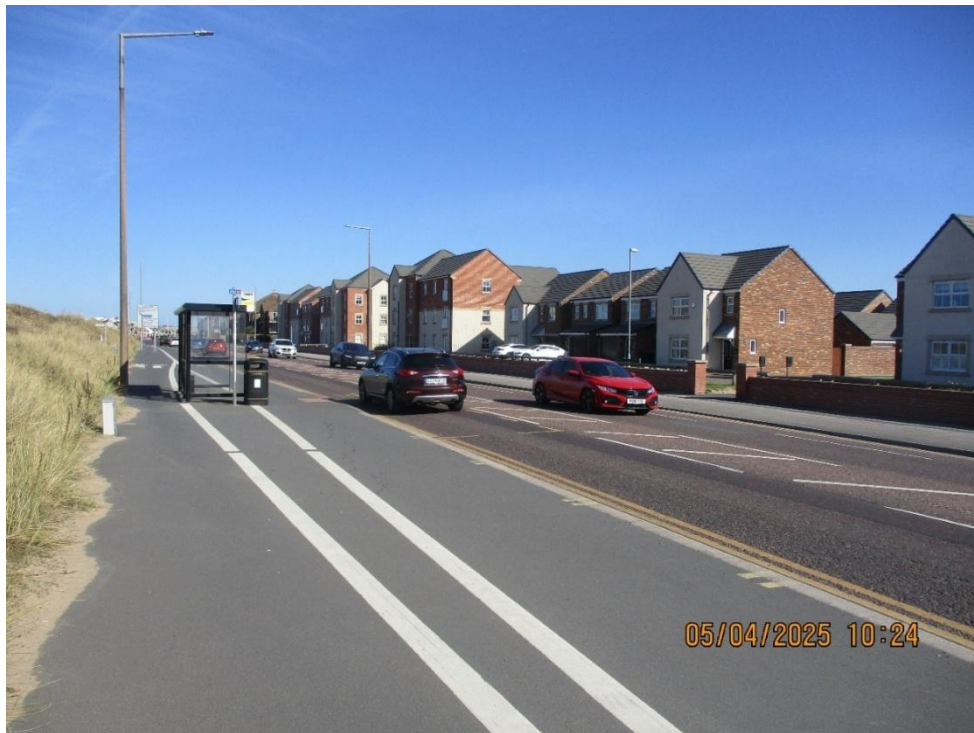
**Photograph A4.6** Sand blowing onto the cycleway at the northern end of Cifton Drive; new housing on fomrer Pontins holiday village site to the right

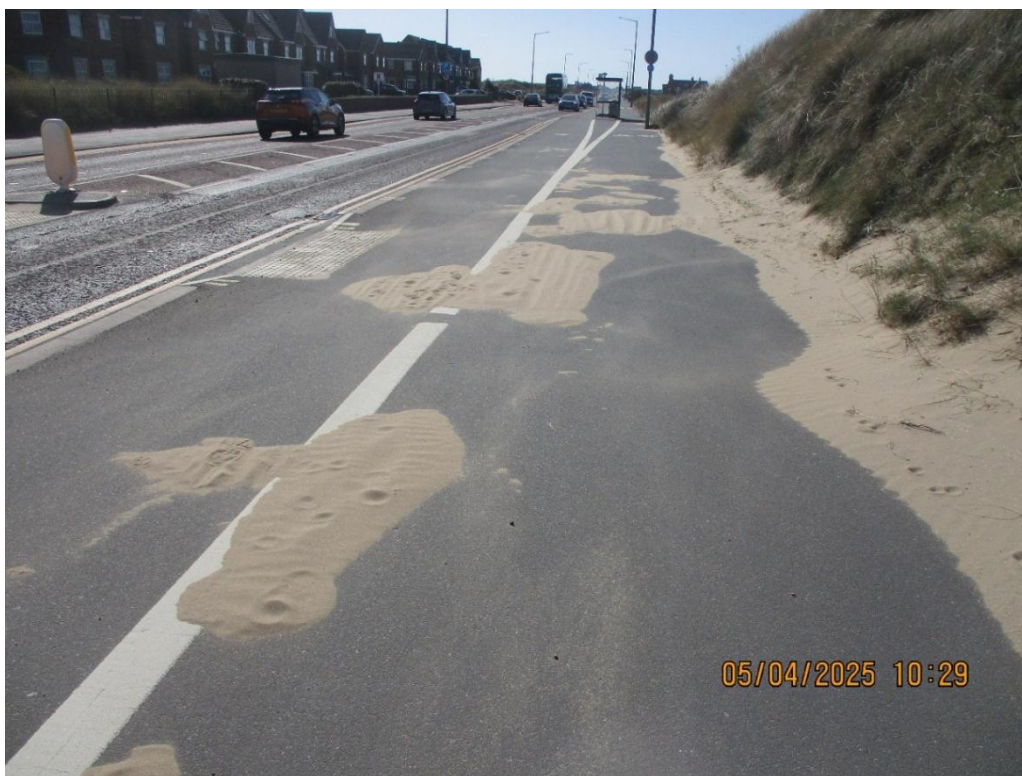
**Photograph A4.7** View south along the northern part of Clifton Drive showing mobile sand incursion from degraded dunes to the right

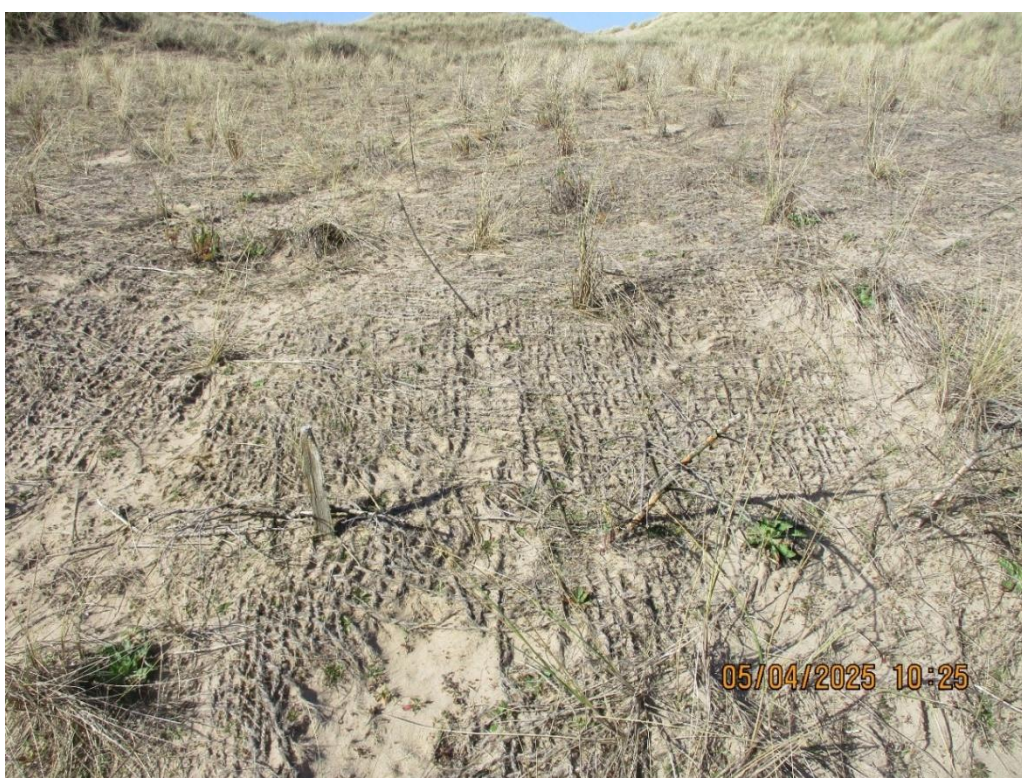
**Photograph 4.8** Geotextile matting and marram planting used in attempts to control sand movement at the northern end of Starr Hills
